Nissan Rogue 2015 to 2020 Blend Door Modification Fix

1/20/24 See **New Notes** on last 5 pages, We have **New lessons learned** from people that had issues installing 3D kit. This includes a 1 year wear report and a new insert created from lessons learned.

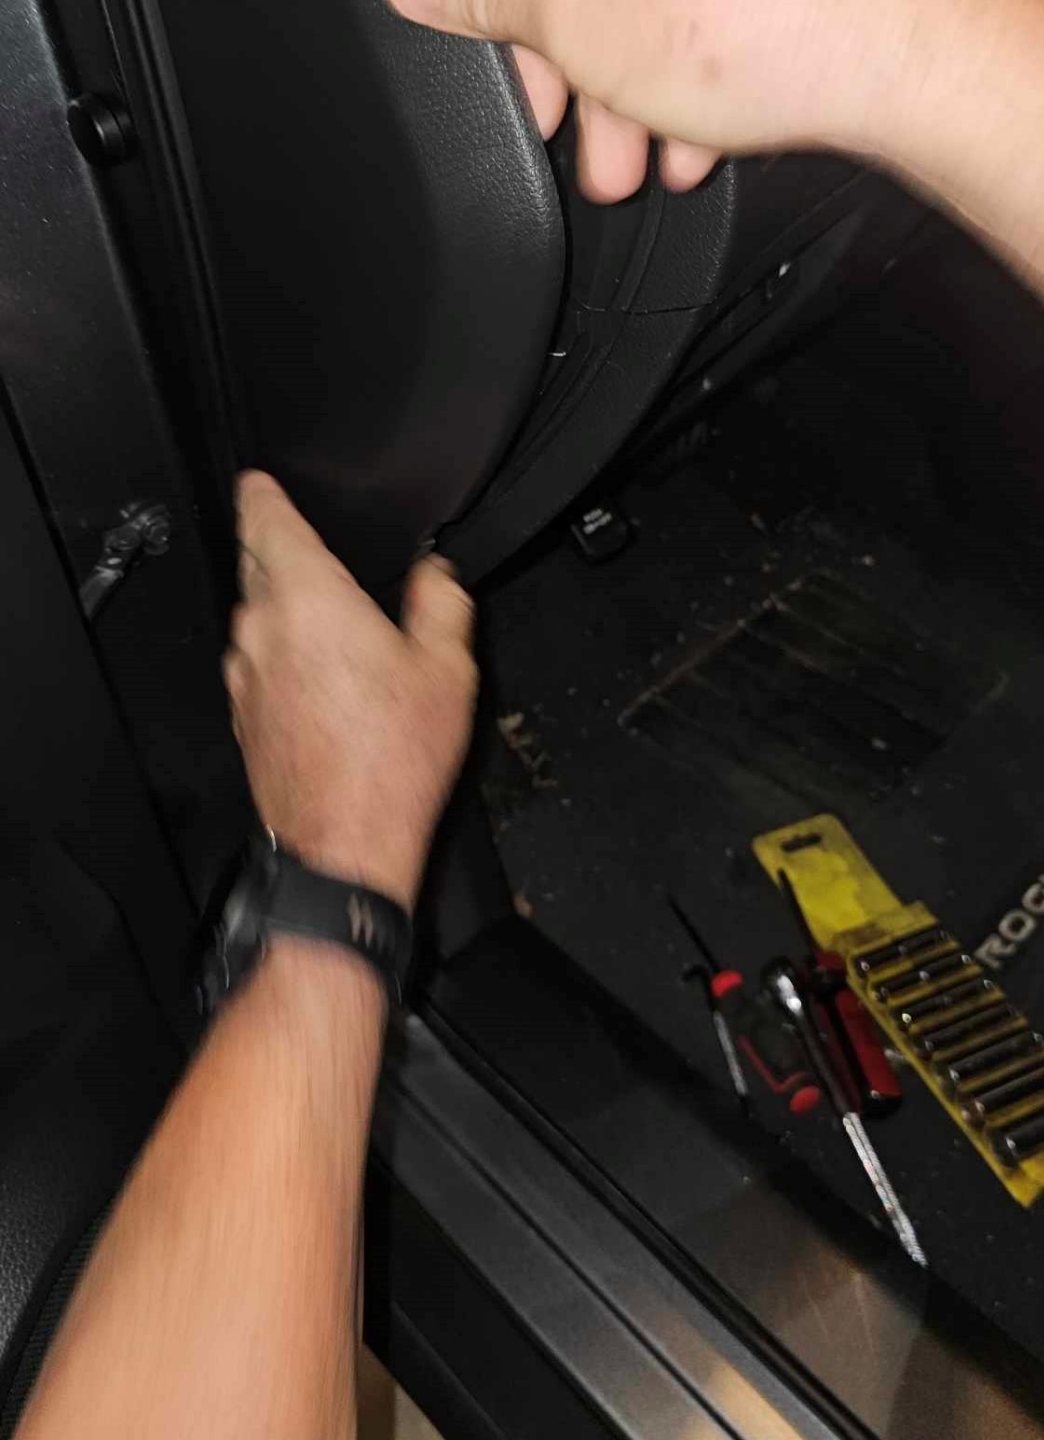
Step1- Remove Fuse
Cover

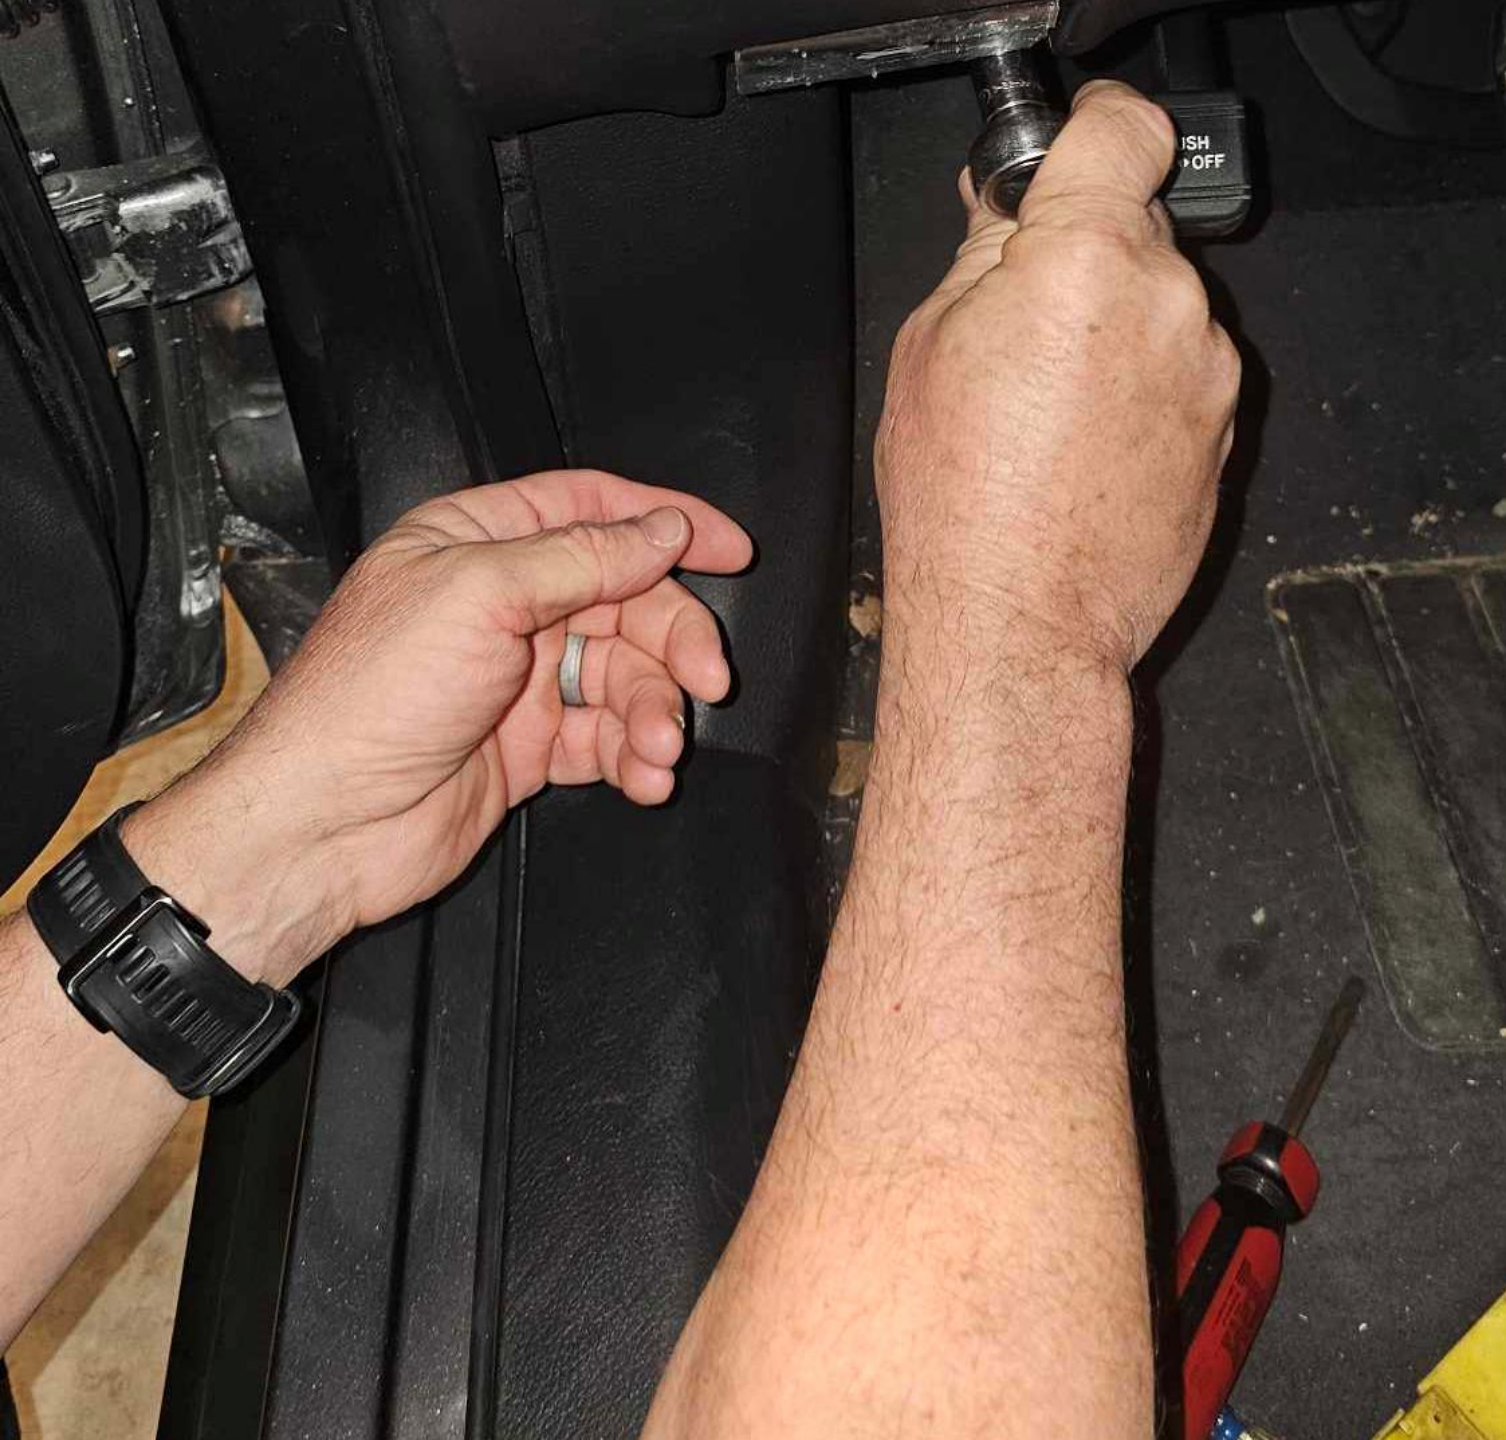
Step2- Remove two 10mm bolts for release lever and let it drop down:

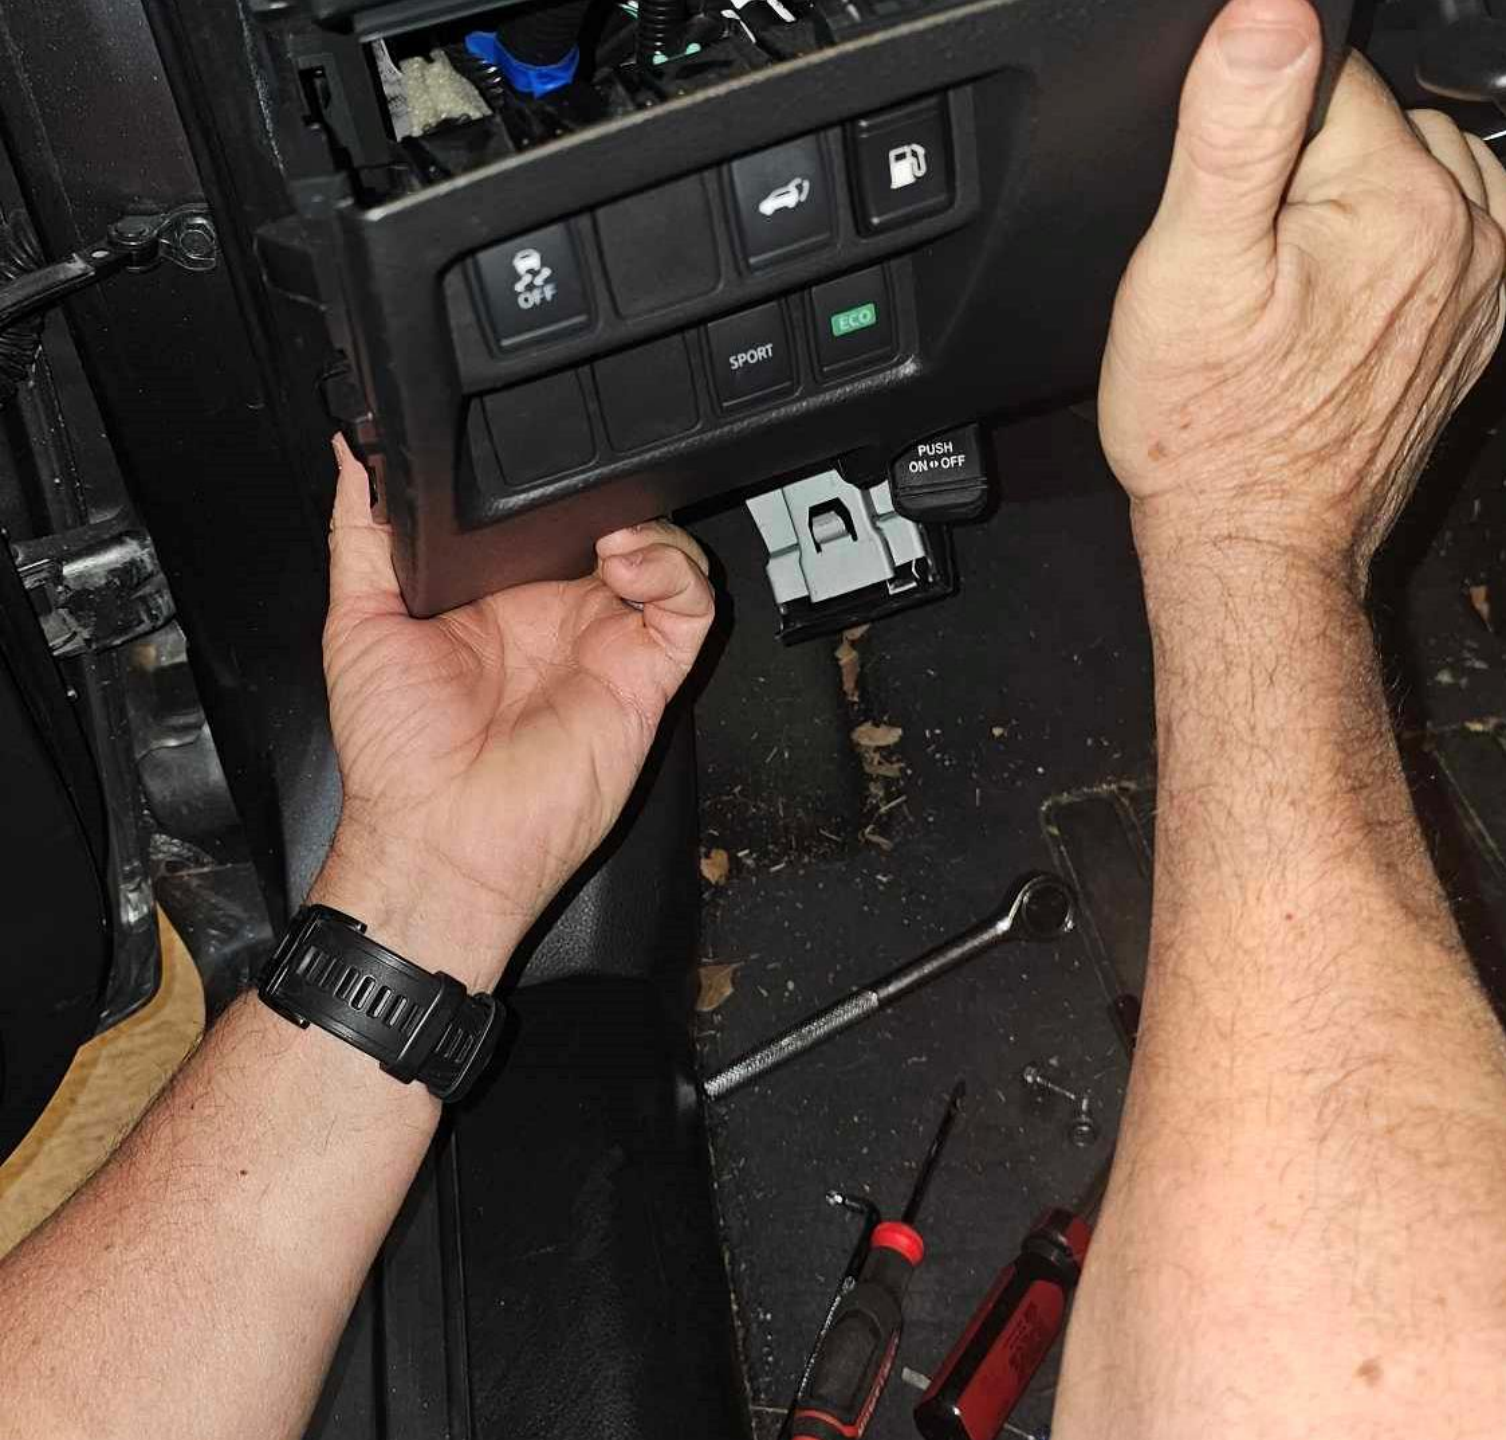
Step3- Remove lower cover, this piece has no bolts and just snaps out. Work its way loose all the way to the center console:

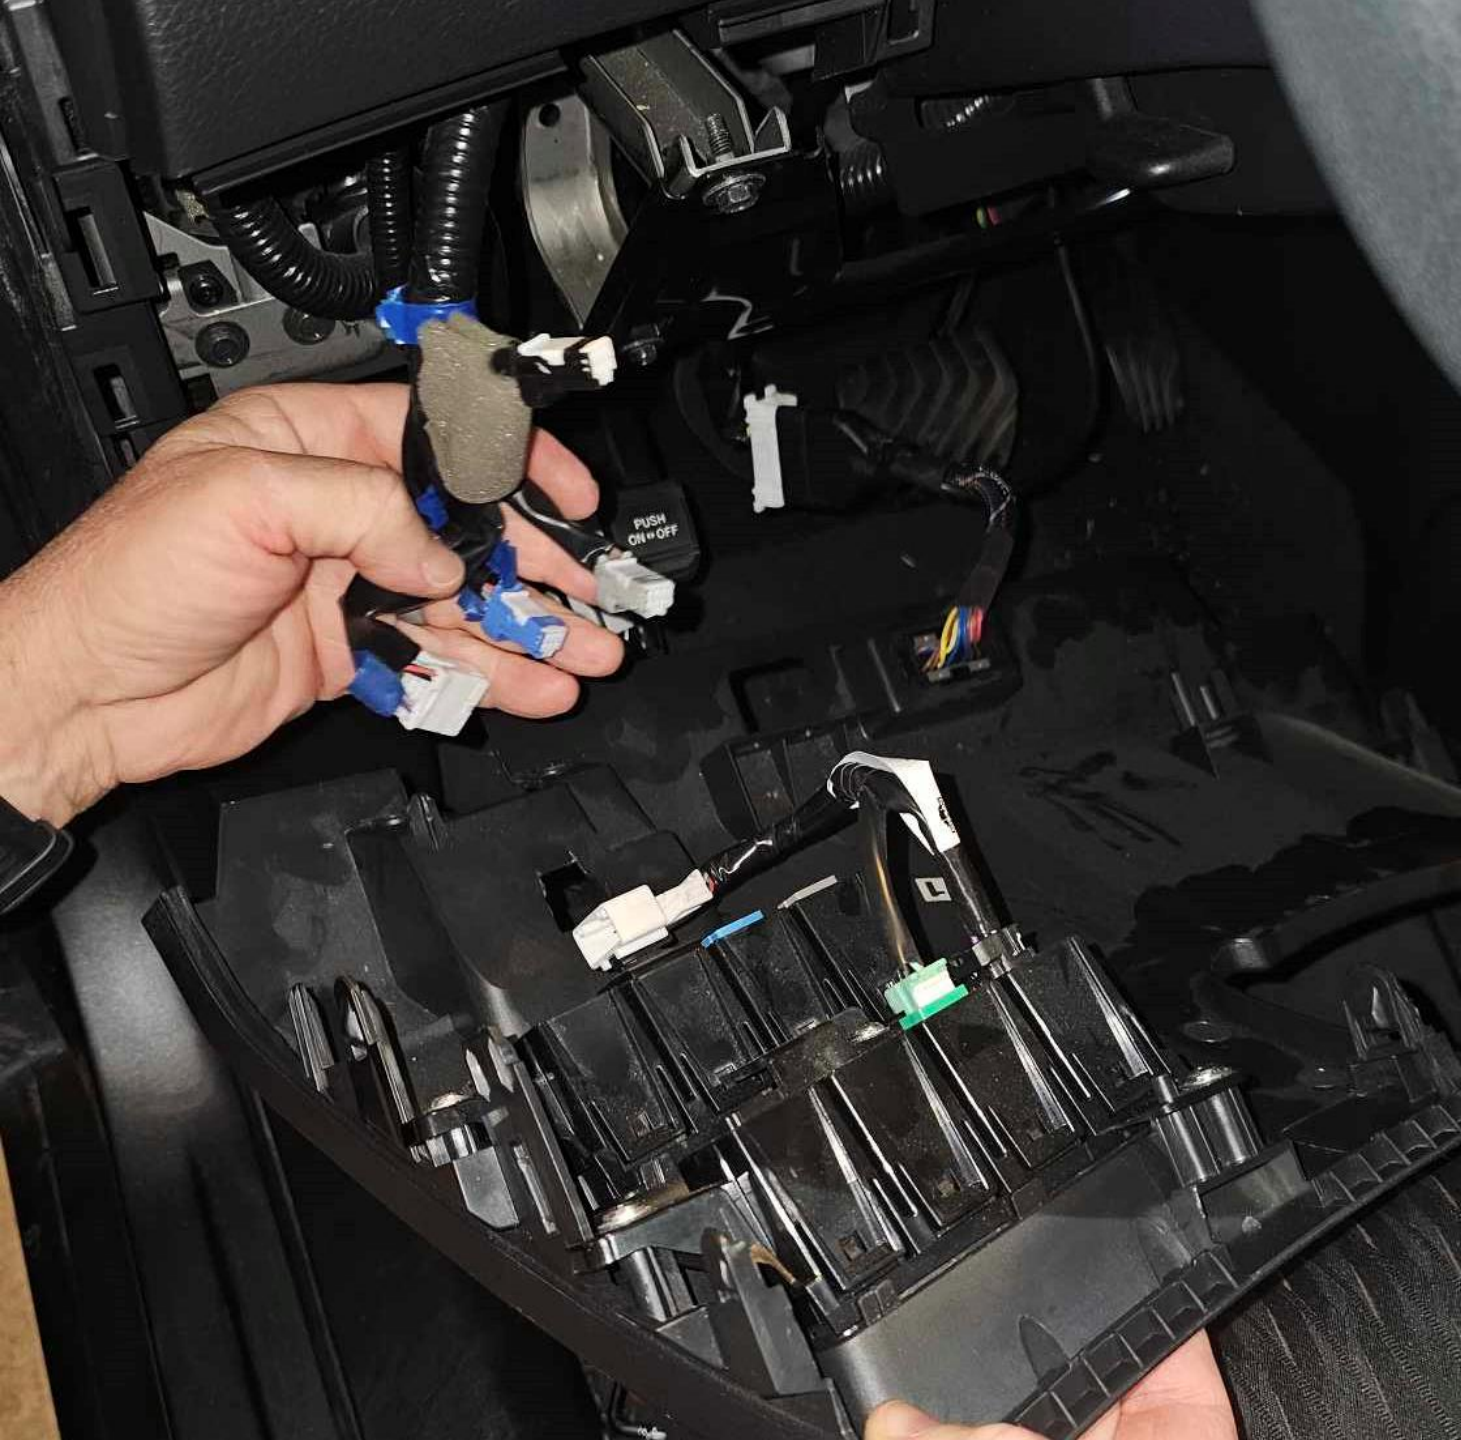
Step4- Remove the connectors on lower console so you can put it aside. Note: there is a connector latch you push down that allows the connector to easily come out. Might need to use small screwdriver to push, my fat fingers had a hard time.

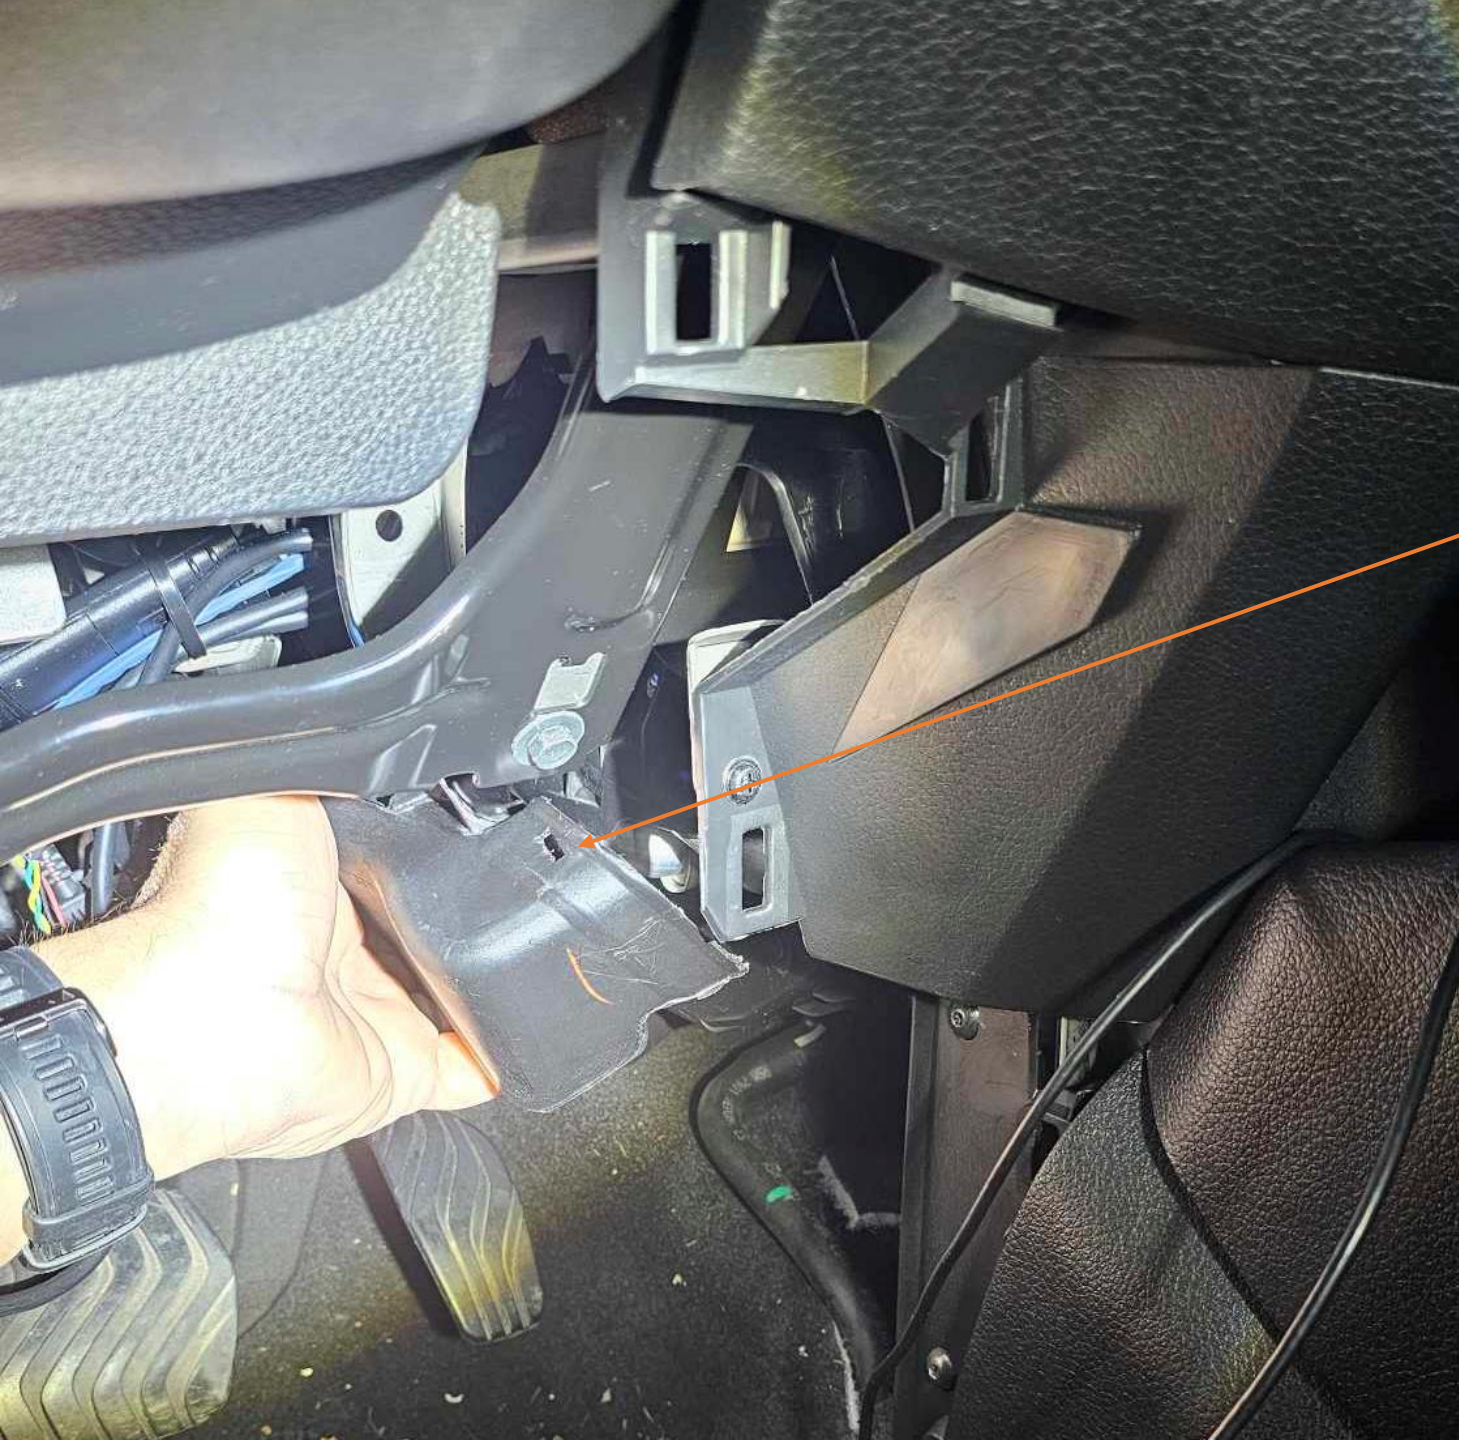
Step6-Remove foot vent.

This Step was the most difficult step for me. I think the best way to remove this is to:

- Remove the phillips screw closest to you.
- Use something to pry off the top part of the vent latch.
- Pull the vent out, while the second screw is still attached.
- Now you can manipulate the vent in a position that makes it a little easier to get the second screw.
- Remove second screw, I had to use a phillips head on a 90 deg bent driver. You could probably get it with a small ratchet with a phillips end.
- Put the vent aside, **you will not reinstall this piece.** The air will just blow from the location you removed it.

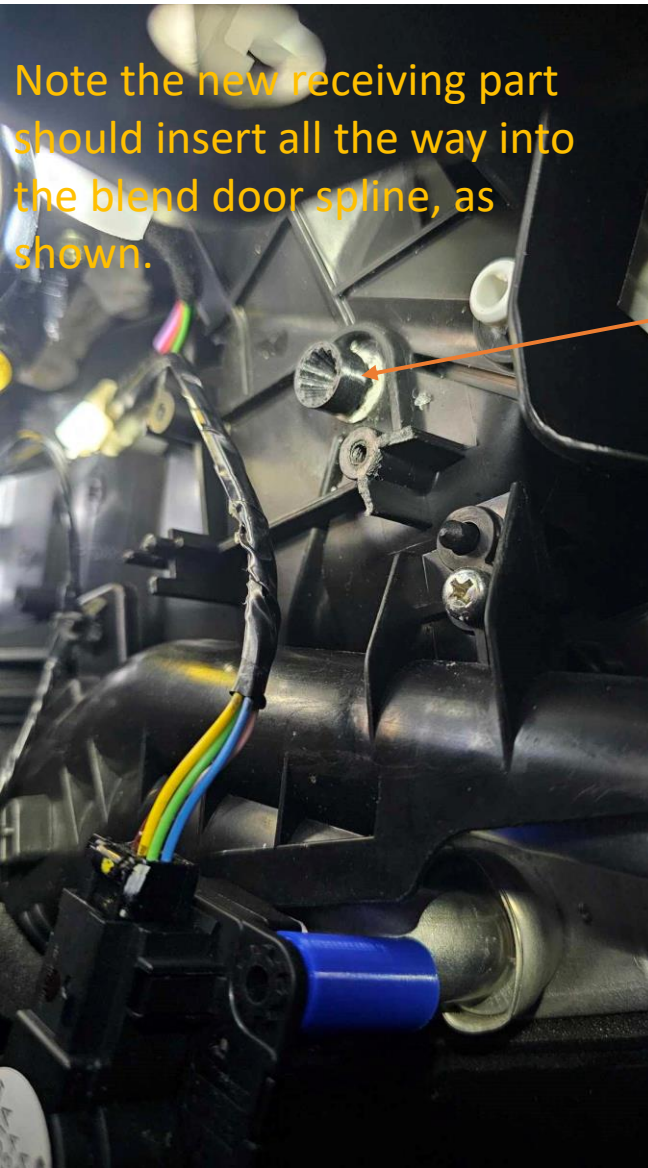
Note the new receiving part should insert all the way into the blend door spline, as shown.

Step 9-Install new receiving spline into stripped spline, on blend door.

- You should be able to turn the blend door at about $\frac{1}{4}$ turn clockwise or counterclockwise by hand. The receiving piece should go all the way in, it may take some force by hand. It must line up with groove in the back of the damaged spline.

- The blend door spline is usually damaged and split at the $\frac{1}{2}$ to $\frac{3}{4}$ depth. This part will slide into the undamaged part. This new design will not allow for the force that would normally strip out the remaining undamaged spline. One of my first design's did not allow for slipping and it sheared off my new part. I assume either HVAC box under the blend door has warped some, because of the heat under it, and caused the door to move less, or the actuator torque and spline design just wears a lot over time.

- If there isn't any undamaged portion in the spline then you may need to glue the part into the spline. See version 2 insert note on the last page. Use and epoxy or JD Weld.

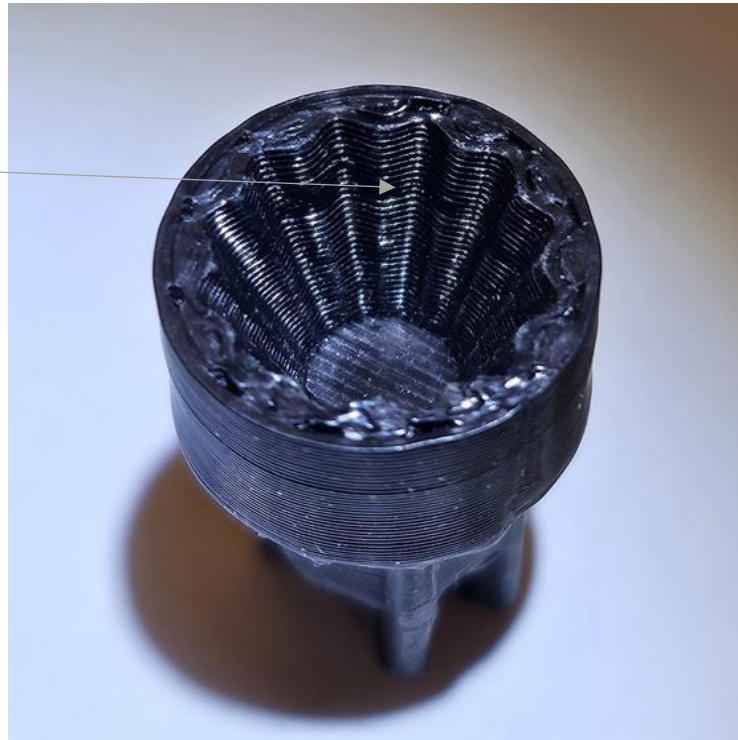
We recently removed the kit we installed a year ago and noted wear. Below is a picture of these parts. The wear was minimal, even under a microscope. It was less than .001 inches. At this rate I would estimate a life of over 5 years with -20 to 80 deg C temp changes.

Not even enough wear to smooth print lines

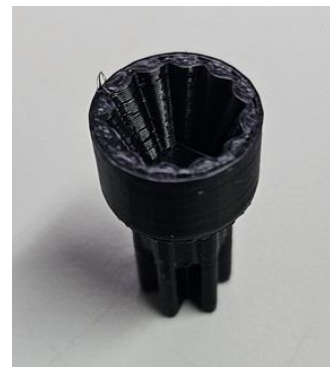
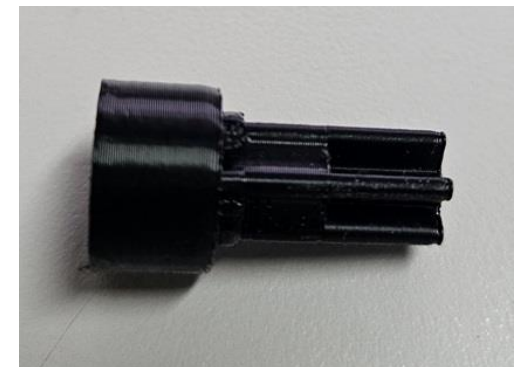
CAD drawing

Actual Picture of print

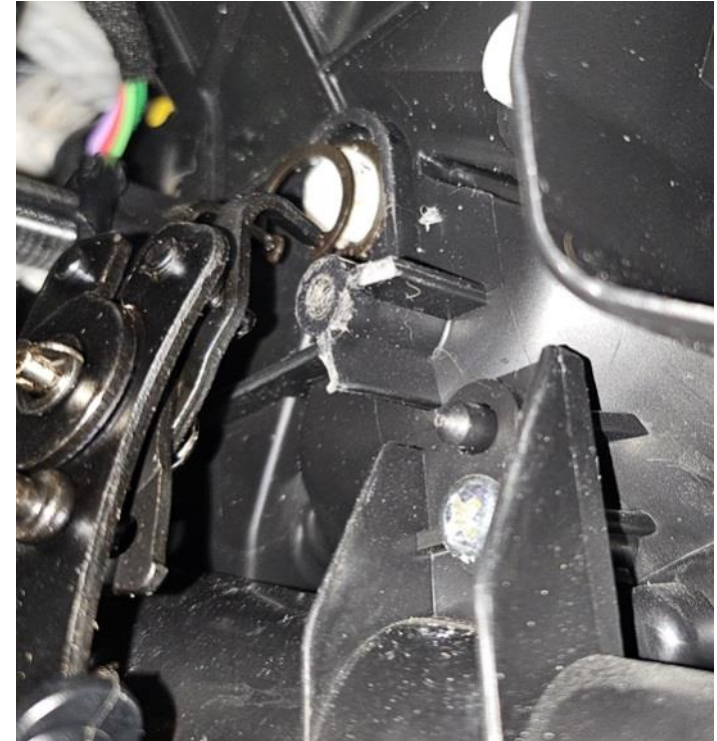
Note for the rare occasion of extensive spline damage.

We had a few customers that had been using a screwdriver to manually turn the blend door as their temporary fix. In this instance or any other repair method used, that has damaged the spline deep into the blend door we have included these cavities so a glue would adhere to the damaged part of the spline.

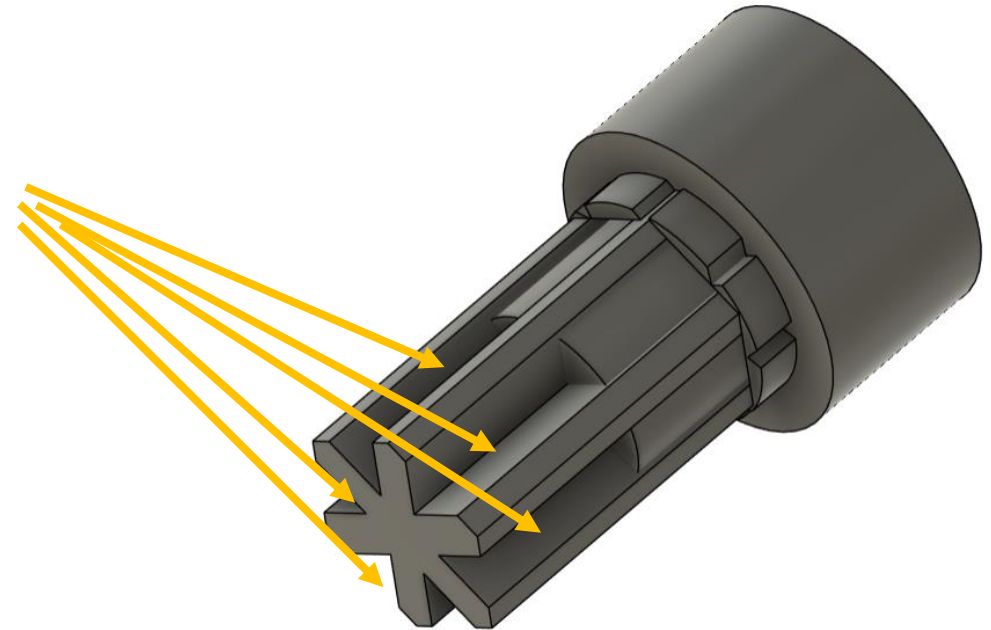
Apply a glue in these cavities and insert. Do not use too much glue as to have it come out the front. We don't want it to glue the blend door from moving.
